# Manhole Inspection Report

**Manhole Number:** MH.5461.01.011

| 2911 Confederate Ave | | | | | |

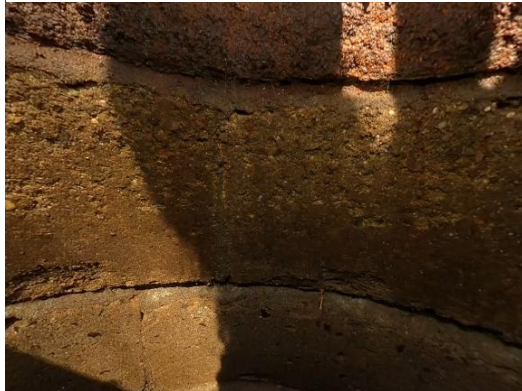
| Distance | Code | | Cont Defect | Value | | | Joint | Step | Circumferential Location | | Grade | Image Reference |
|---|---|---|---|---|---|---|---|---|---|---|---|---|
| 0.5 | COI | SAV | | | | | Yes | No | 12 | 12 | 2 | H.5461.01.011_20260216_SAV_1.j |

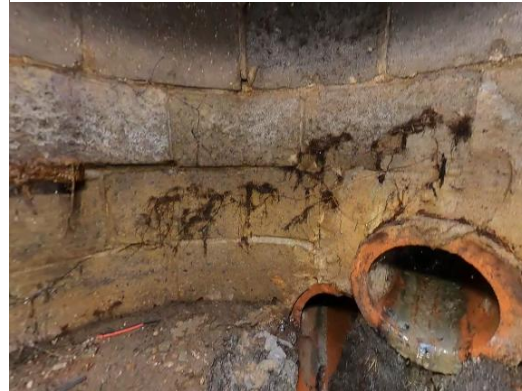
| Distance | Code | | Cont Defect | Value | | | Joint | Step | Circumferential Location | | Grade | Image Reference |
|---|---|---|---|---|---|---|---|---|---|---|---|---|
| 3.7 | WI | RFJ | | | | | Yes | No | 12 | 12 | 1 | H.5461.01.011_20260216_RFJ_1.j |

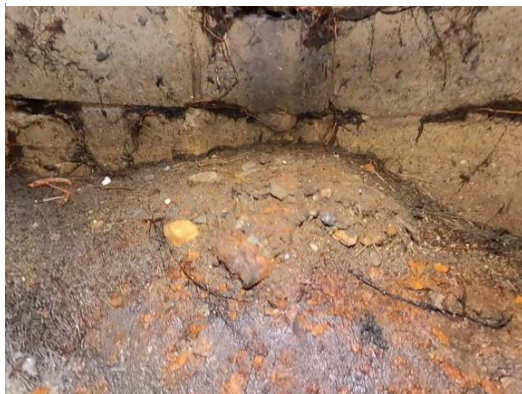
| Distance | Code | | Cont Defect | Value | | | Joint | Step | Circumferential Location | | Grade | Image Reference |
|---|---|---|---|---|---|---|---|---|---|---|---|---|
| 5.5 | B | DSZ | | | | 100 | No | No | 12 | 12 | 2 | H.5461.01.011_20260216_DSZ_1.j |
| Remarks | Rocks, Fine, Roots | | | | | | | | | | | |

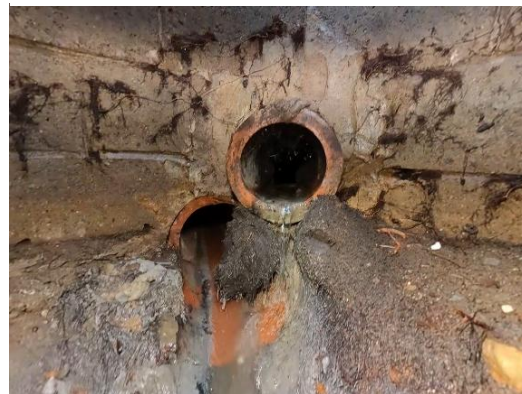
| Distance | Code | | Cont Defect | Value | | | Joint | Step | Circumferential Location | | Grade | Image Reference |
|---|---|---|---|---|---|---|---|---|---|---|---|---|
| 5.6 | WI | RFC | | | | | No | No | 12 | | 1 | H.5461.01.011_20260216_RFC_1.j |
