# Manhole Inspection Report

**Manhole Number:** MH.5461.01.011

| 2911 Confederate Ave | | | | | |

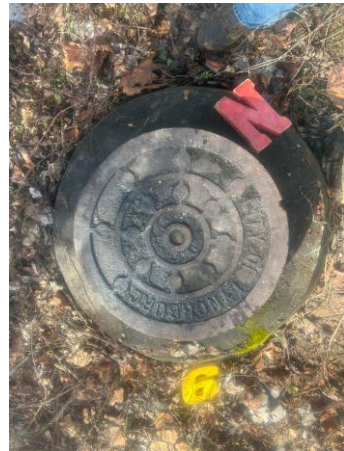
MH.5461.01.011\_20260216\_Cover.jpg

| <input type="checkbox"/> Vented | <input type="checkbox"/> Inner | <input type="checkbox"/> 2 Hatch | <input type="checkbox"/> Cracked | <input checked="" type="checkbox"/> Corroded | <input type="checkbox"/> Restraint Defective |

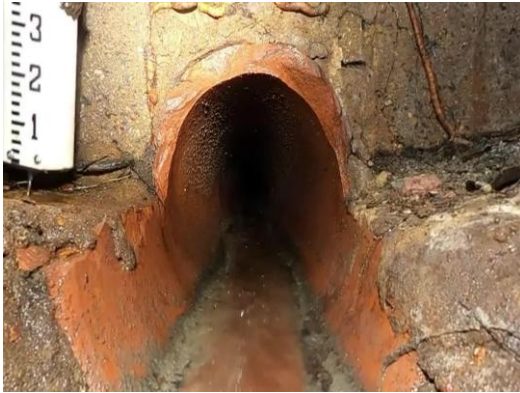
Pipe Clock Postion: 6

| Pipe Num | Clk Pos | Pipe Dir | Pipe Depth | Pipe Material | Pipe Shape | Pipe Dia | Seal Condition | Special Condition | Access Point ID |
|---|---|---|---|---|---|---|---|---|---|
| 1 | 6 | O | 5.8 | VCP | C | 10 | S | GR | |

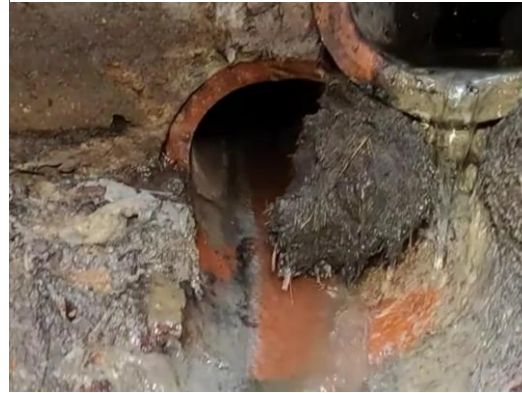
Pipe Clock Postion: 11

| Pipe Num | Clk Pos | Pipe Dir | Pipe Depth | Pipe Material | Pipe Shape | Pipe Dia | Seal Condition | Special Condition | Access Point ID |
|---|---|---|---|---|---|---|---|---|---|
| 2 | 11 | I | 5.8 | VCP | C | 10 | S | GR | |

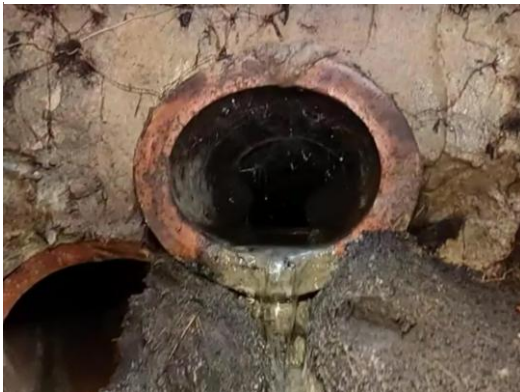
Pipe Clock Postion: 12

| Pipe Num | Clk Pos | Pipe Dir | Pipe Depth | Pipe Material | Pipe Shape | Pipe Dia | Seal Condition | Special Condition | Access Point ID |
|---|---|---|---|---|---|---|---|---|---|
| 3 | 12 | I | 5.1 | VCP | C | 8 | S | GR | |
